From: Stephen DiCicco

Date: 7/22/2011

Subject: RAMPP West Virginia LiDAR QA/QC: Coal River Delivery

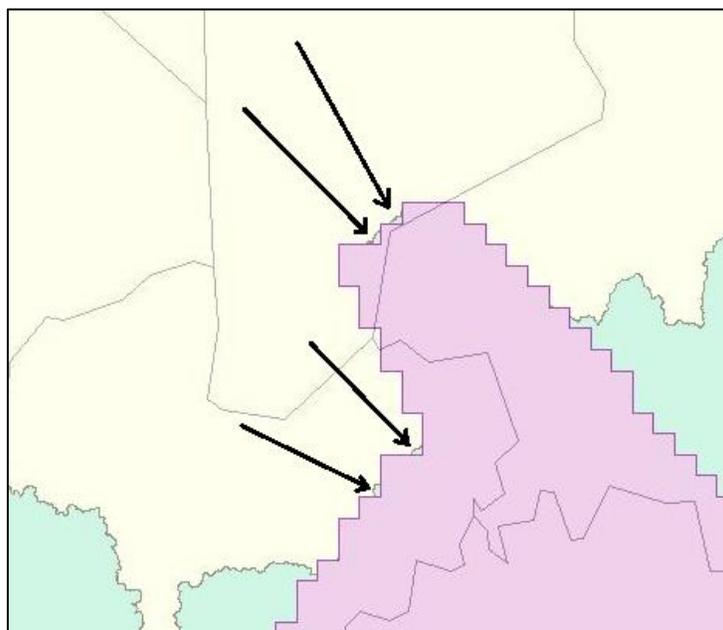
Figure 2 shows a close up view of the Coal River delivery overlaid on the West Virginia area of interest. The northernmost portion of Coal River tiles borders the area of interest but falls short in four places. These gaps range from 0.1 to 0.2 mi². Though not an error, trajectories show that LiDAR was flown for these gaps. Processing these portions with this delivery, if they are to be processed, would have been most efficient.

Figure 2- Northern portion of the Coal River delivery. Four small portions of the greater West Virginia project area are not covered by Coal River tiles.

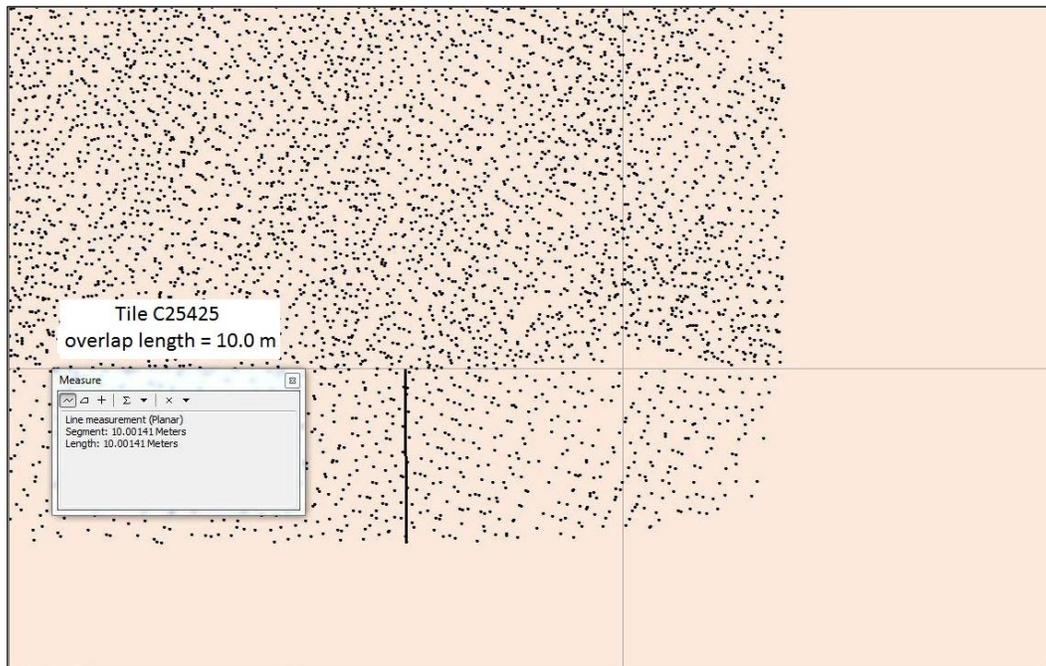
The LAS tiles overlap each other and the West Virginia tile scheme by approximately 10 meters on all sides. Figure 3 shows LAS tile C25425 converted to an ESRI multipoint file and overlaid on the project tile scheme. The overlapping portion of points which extends past the tile boundary and is duplicated by the neighboring tiles is measured at 10.0 m in length. This is not consistent with the scope of work which specifies seamless tiles. As discussed subsequently in the LiDAR QA/QC section of this report, the LAS overlap also causes classification errors along tile seams. The tiles should be trimmed and edges should be inspected for remaining artifacts.

Figure 3- The LiDAR points exceed the tile boundary by approximately 10 m.

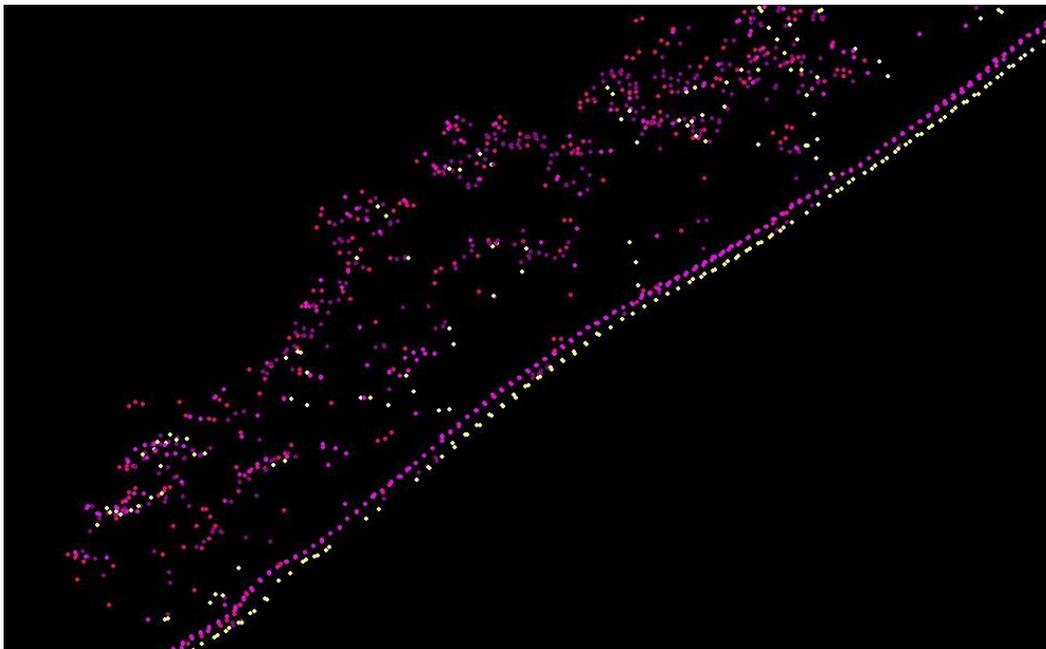
Flight trajectories for the Coal River delivery show sections of dense overlapping flight lines which are assumed to be re-flights. Several flight line offsets were detected in areas where multiple flight lines overlap; primarily the re-flight areas. Figure 4 shows a profile from tile C21975 colored by flight source identification. Pink and purple points (which appear similar) are from flight lines s_173 and s_374 respectively. Yellow points are from flight line s_121. Flight line s_121 is up to 1 m lower than the other two.

In some cases, like in Figure 4 the flight line offset is “classified out” meaning the lower of the two lines was classified to ground and the upper to unclassified. This may affect the absolute vertical accuracy of the data if tested in this location. Additionally, noise and flight line ridges which can be attributed to the flight line offsets are seen in the ground models.

Figure 4 - A profile from LAS tile C21975 colored by flight source ID. A flight line offset which measures up to 1 m is visible.

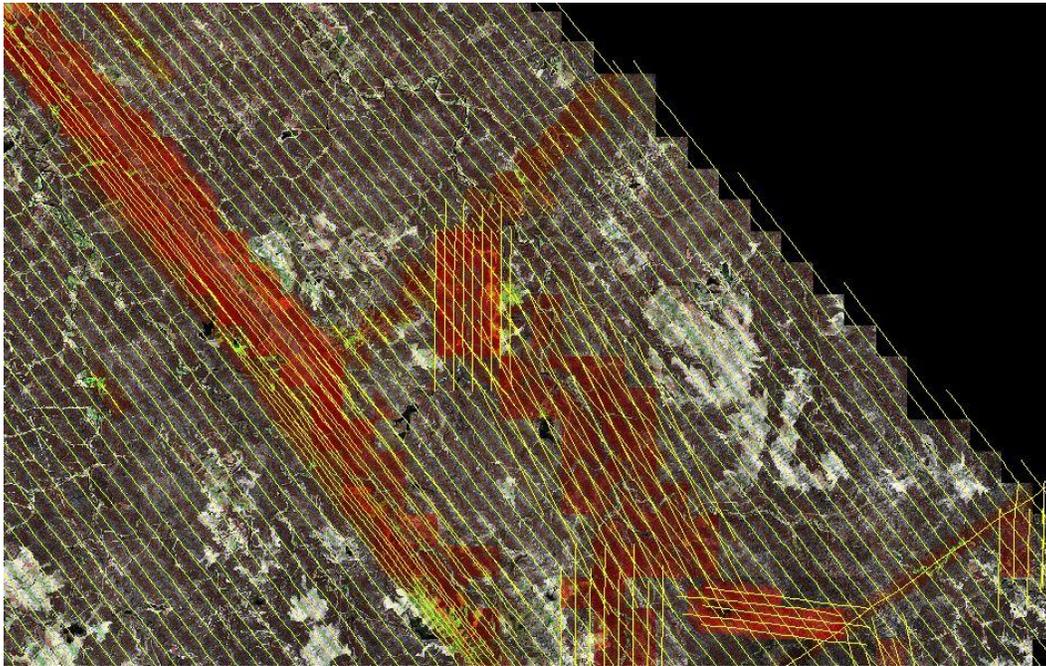
Figure 5 shows a mosaic of Delta-Z ortho images created using only first return points. Overlaid are the flight line trajectories. The red tiles are an indication that a flight line offset may exist. Areas containing the greatest portion of red clearly correspond to re-flights. RAMPP recommends all tiles containing re-flight trajectories be examined and corrected for flight line offsets. Some flight lines along which offsets are known to exist include:

Figure 5 - Delta-Z ortho images for several West Virginia tiles with flight line trajectories shown in yellow. Red indicates a flight line offset may exist. Areas containing the greatest amount of red correspond to re-flight and trajectories.

- s_363 s_158 s_169 s_148 s_414 s_151 s_378 s_121 s_375
- s_364 s_159 s_559 s_149 s_152 s_111 s_122 s_380

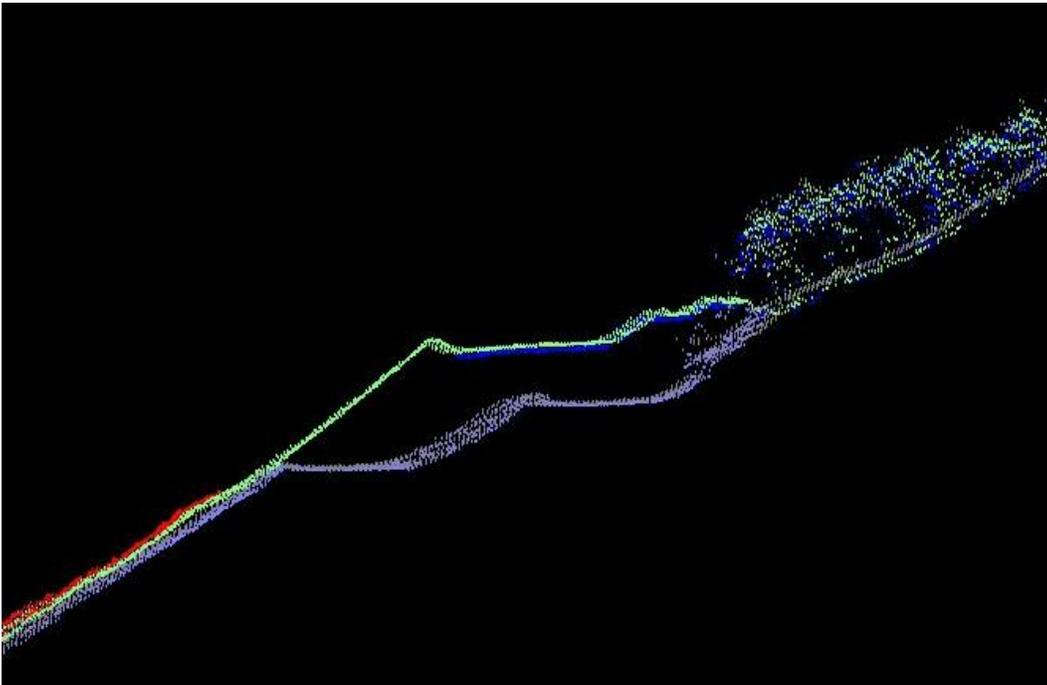
Also noted within tiles covered by re-flights were actual changes in the ground which occurred between flight dates. **Error! Reference source not found.** shows a profile from LAS tile C23751 colored by flight source identification where mining has altered the shape of the ground significantly. In these cases, the more recent depiction of the ground should be consistently classified. Classifying flight lines depicting different ground conditions together contributes to flight line ridges and noise and will add uncertainty to the vertical accuracy calculation. RAMPP recommends checking any tiles with a large span of time between its start and end flight date for significant temporal changes.

Figure 6- A profile from LAS tile C23751 colored by flight source ID. The landscape has changed significantly between flight dates.

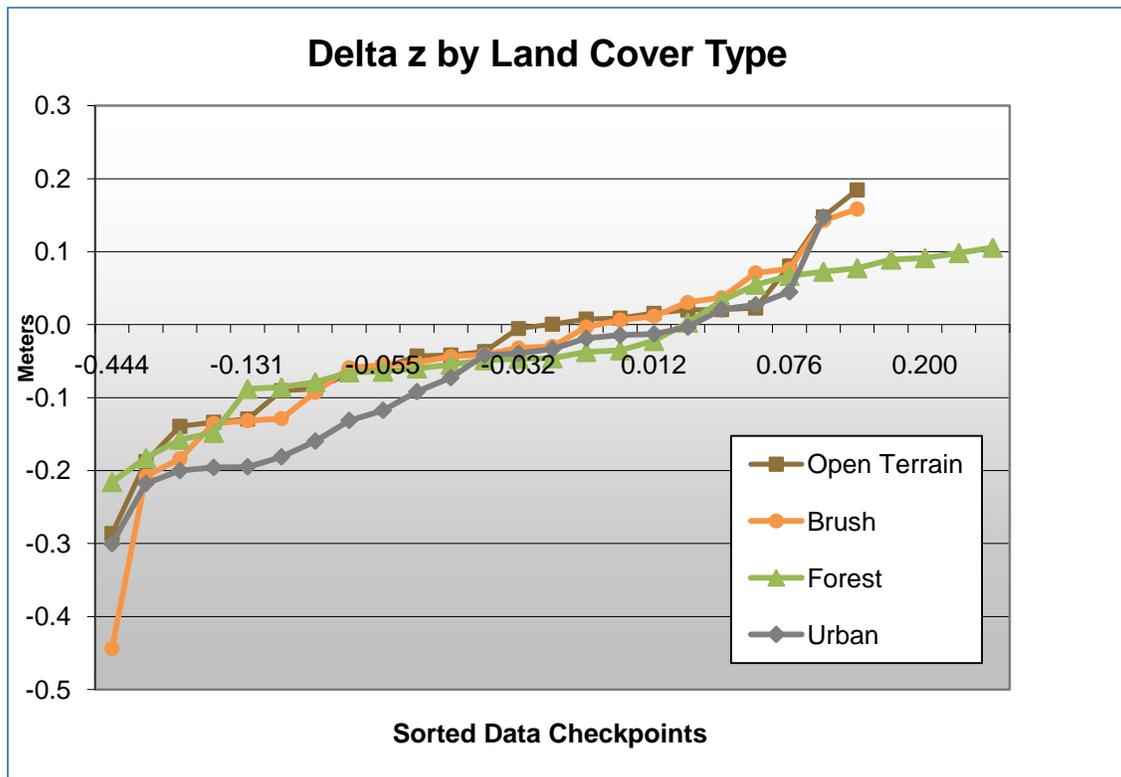
Figure 9 - Coal River checkpoint delta z values by land cover type.

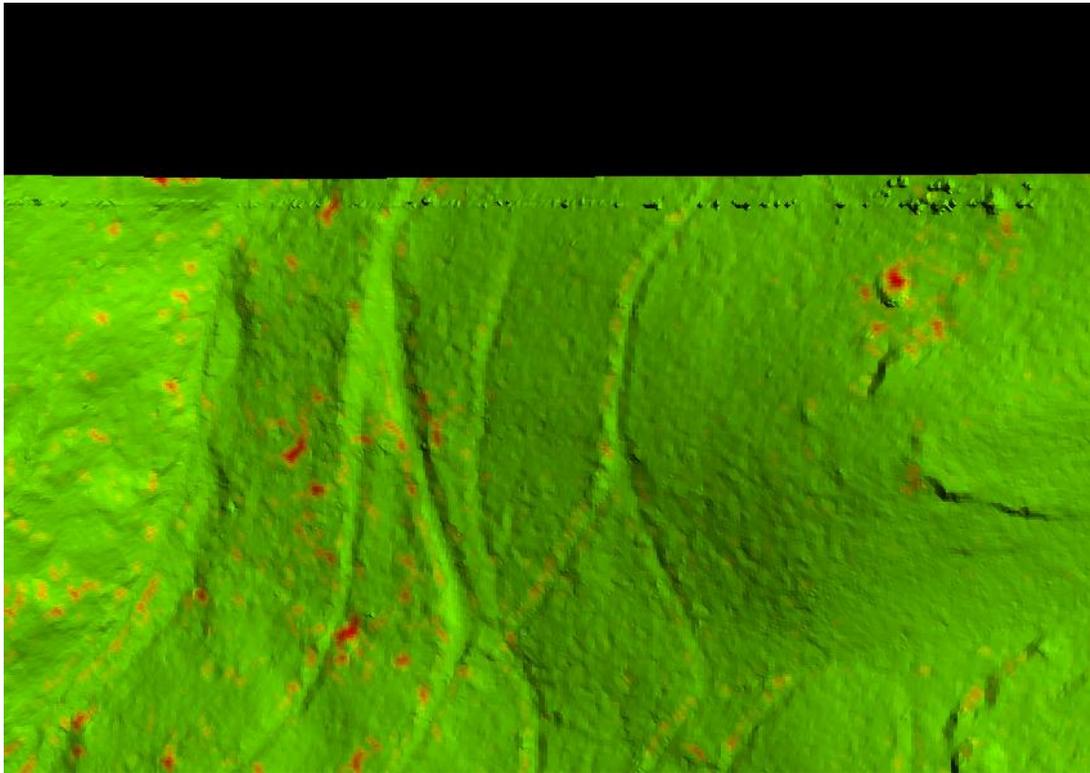
Overlap in the tiles resulted in inconsistent editing along tile edges. Generally the main 1.5 km portion of the tile was classified while the overlapping portion was not. This left a line of artifacts along the edge of the tile ground models. Figure 11 depicts the line of artifacts left in the ground density model of tile C22728. All tiles contained this error along all or some of their edges. The tiles should be clipped then reviewed for remaining artifacts along seams.

Figure 11- Tile C22728 shows a line of vegetation artifacts along its overlapping edge.

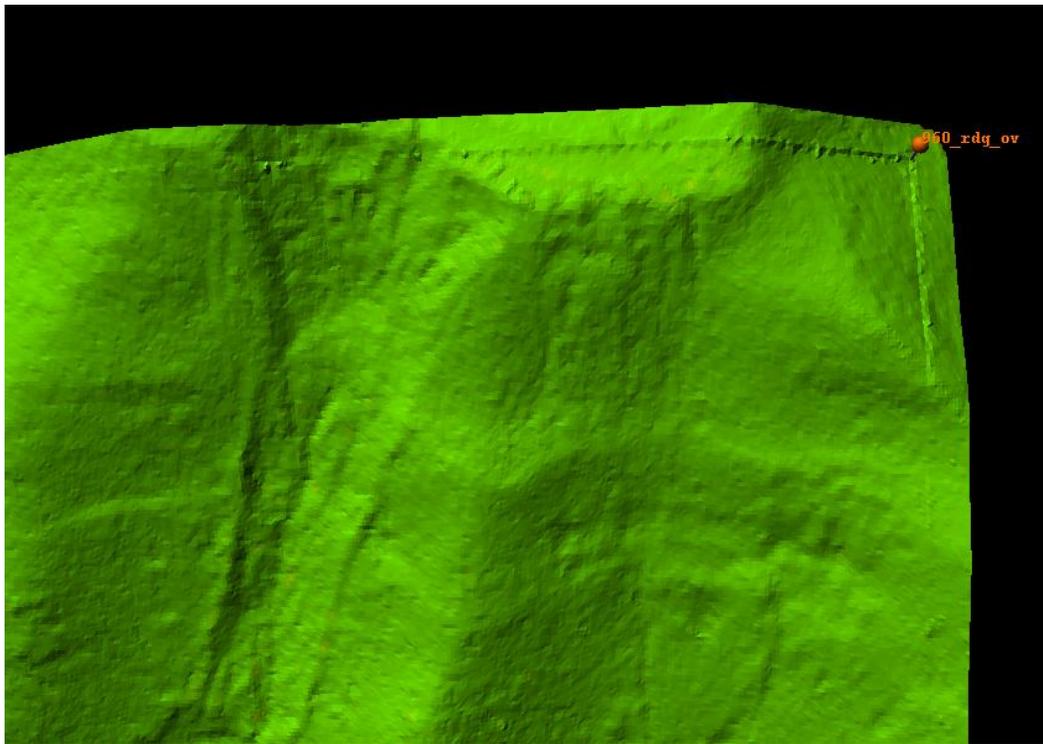
In very limited cases, a ridge appeared in the overlapping portion of the tiles. This signifies a change in ground elevation from one tile to the next and is likely a result of flight line offsets. Figure 12 shows a ridge in the overlapping corner of tile C23751. This tile was used previously to depict a significant temporal change and is known to contain flight line offsets.

Figure 12 – A ridge formed by the overlap between tile C23751 and its neighbors. This signifies a flight line offset.

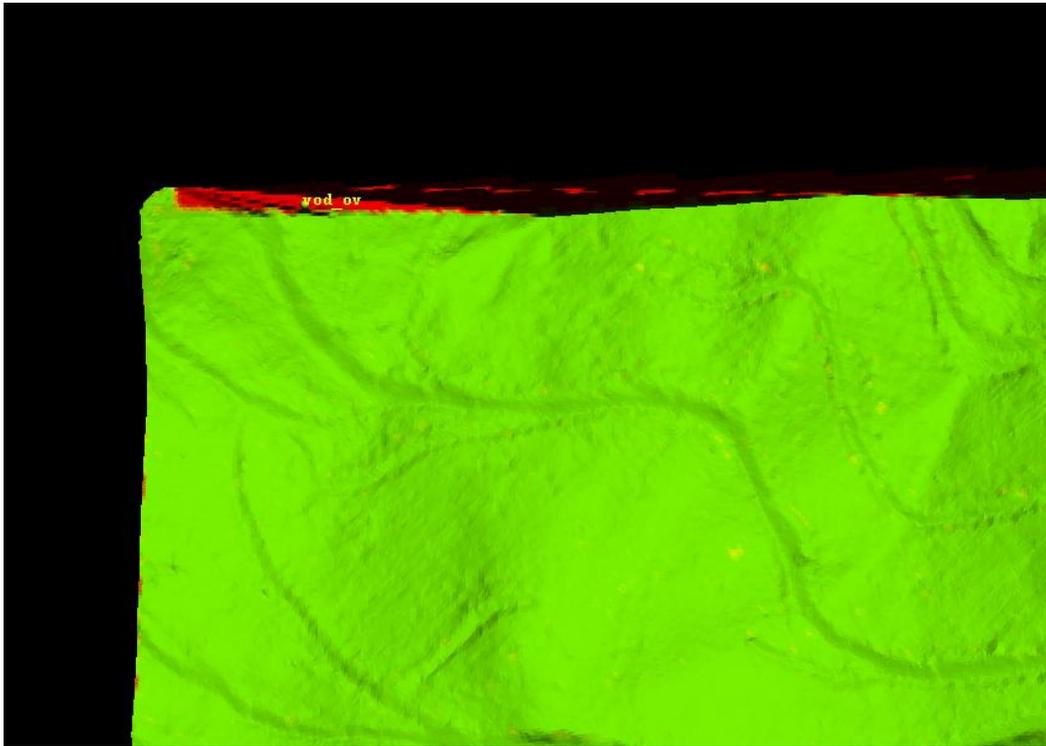
In limited cases, a void was present on one more tile edges. These are not actual data voids but are a product of the tile overlap. No data voids were found in the full point cloud Delta-Z ortho images meaning these voids will be filled by the overlap of neighboring tiles. Figure 13 depicts one such void in red for the ground density model of tile C24832.

Figure 13 – A data void on the overlapping edge of tile C24832. This will be filled by the overlap of the tile above.

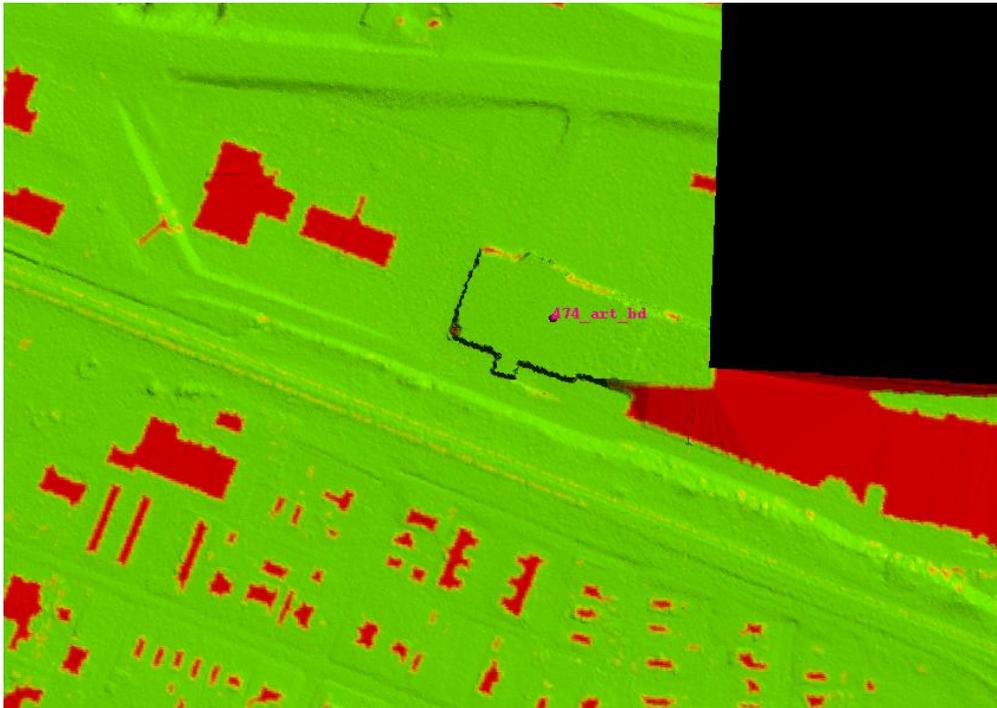
A small portion of artifacts including buildings, bridges and vegetation which exceed the specified maximum of 20 cm and will impact the ground model were left classified into ground. Significant artifacts were marked according to their type. Large artifacts should be reclassified. Figure 14 shows a large building left classified in ground for tile C18075. This was the largest artifact found in the five percent review.

Figure 14 – A large building artifact left in the ground density model of tile C18075.

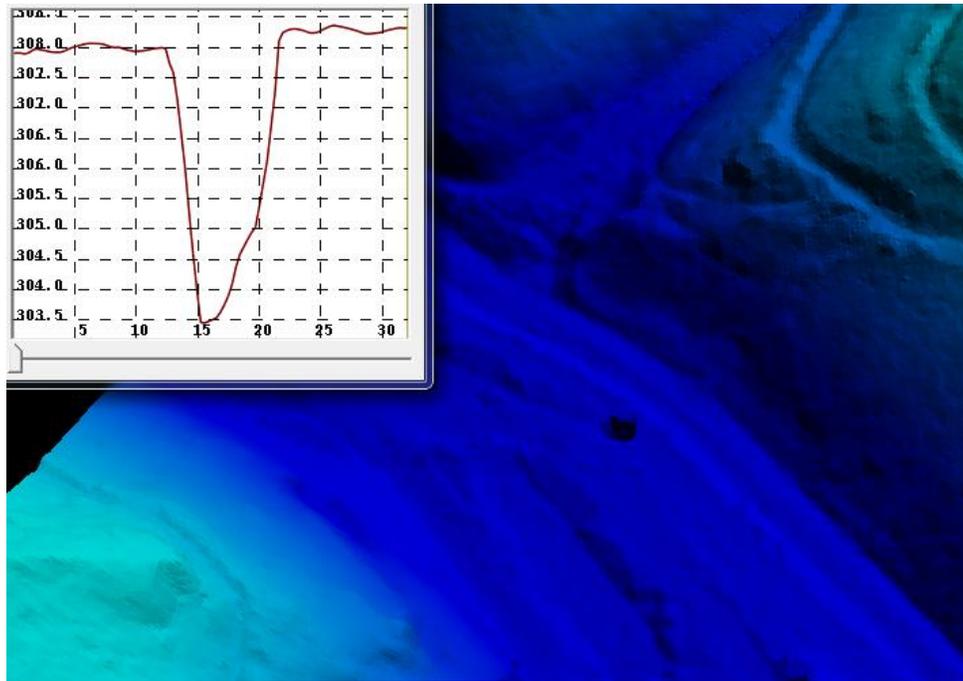
Also typical of LiDAR, several small divots were noted in the ground models. These do not have a significant effect on the ground model. Only significant divots were marked. Figure 15 shows an example of a significant divot. Few large divots were identified.

Figure 15 – A large divot in the ground elevation model of tile C23321.

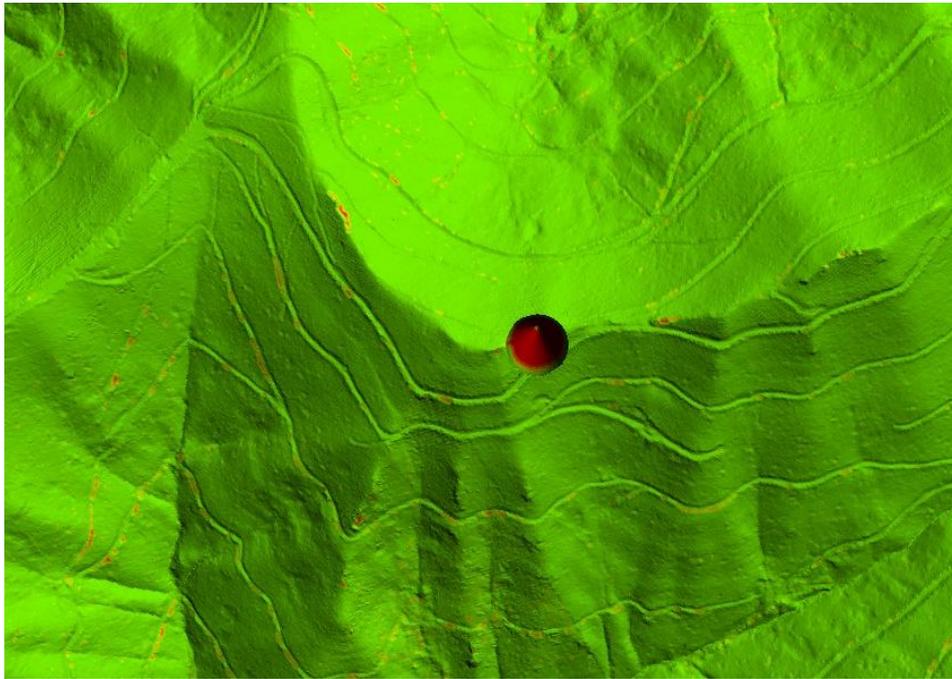
Both major and minor misclassifications of ground points were observed. Two large circular holes were noted where ground point were misclassified into class 1. Figure 16 shows this misclassification as it appears in the ground density model. Figure 17 shows a profile of the LiDAR points colored by classification. Ground points are shown in pink, unclassified points in yellow. The mistaken classification of points in the circular area is clear.

Figure 16 – An unnatural hole in the ground model of tile C24029 caused by misclassification of ground points to unclassified.

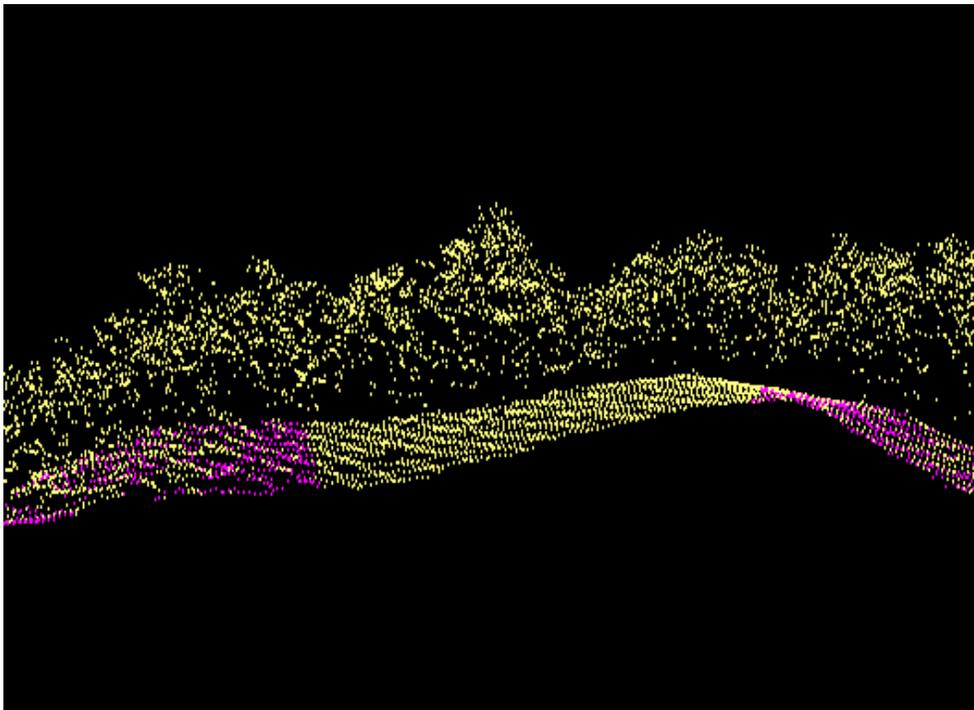
Figure 17 – A profile of the misclassification in LAS tile C24029. Ground points are shown in are pink, unclassified points are in yellow.

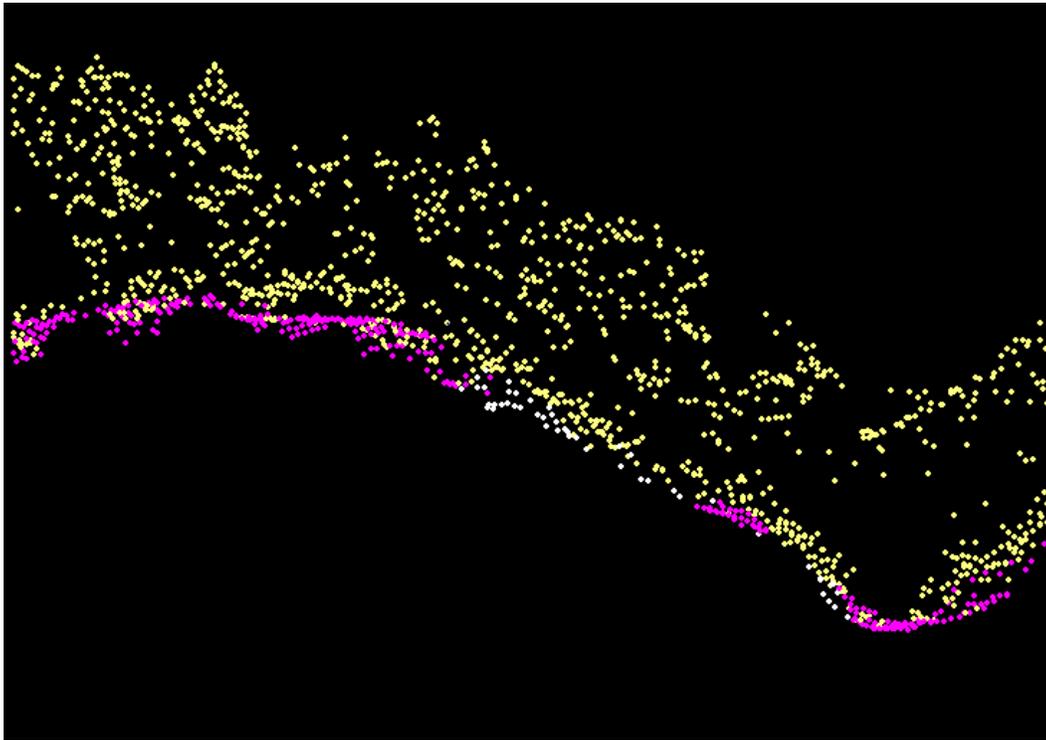
There are several occurrences of misclassifying points to class 7, noise, in the data. Several areas of low point density which appeared to be caused by poor LiDAR penetration actually contain clear ground points which are misclassified into noise. Figure 18 shows LAS points colored by classification for a forested area where ground points are misclassified to noise.

Figure 18 – A profile from LAS tile C26638 colored by classification showing misclassification of ground points to noise. Pink is ground; yellow is unclassified and white is noise. Misclassified noise points towards the center of the profile are clearly in line with the ground.

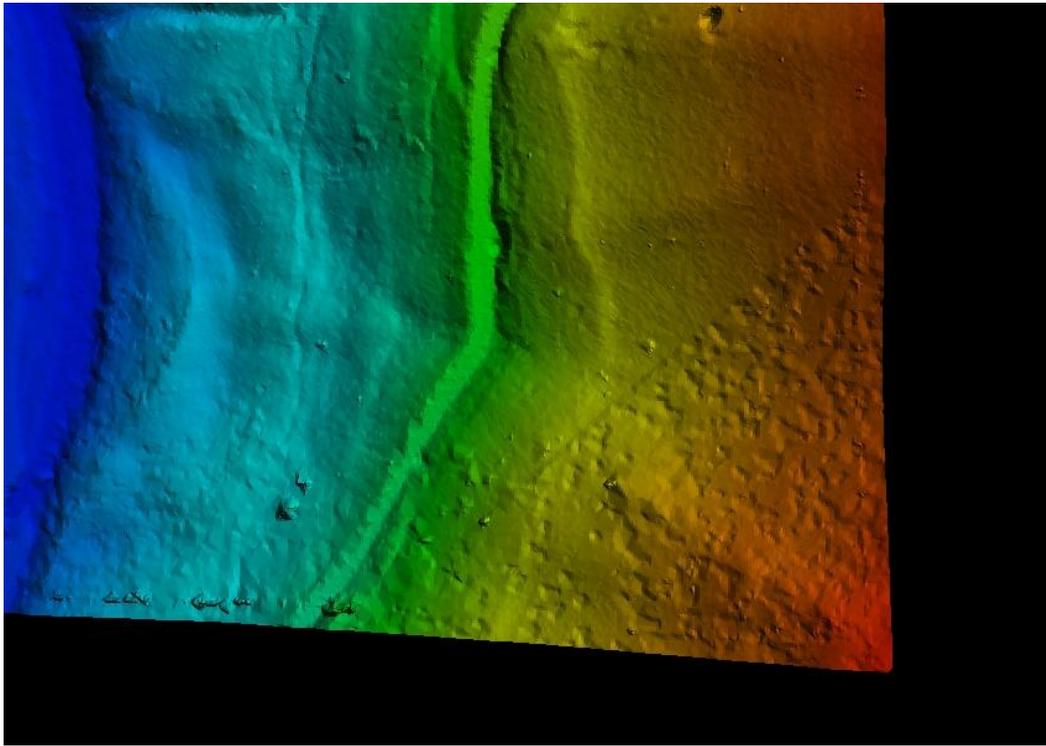
As previously mentioned, a limited number of flight line ridges were detected in the QA sample. These occurred in areas previously determined to contain flight line offsets. Figure 19 shows a flight line ridge present in tile C21975. While ridges are generally linear like that in Figure 19, other flight line ridges in the data were affected by inconsistent classification and have varying patterns.

Figure 19 – A flight line ridge in tile C21975.

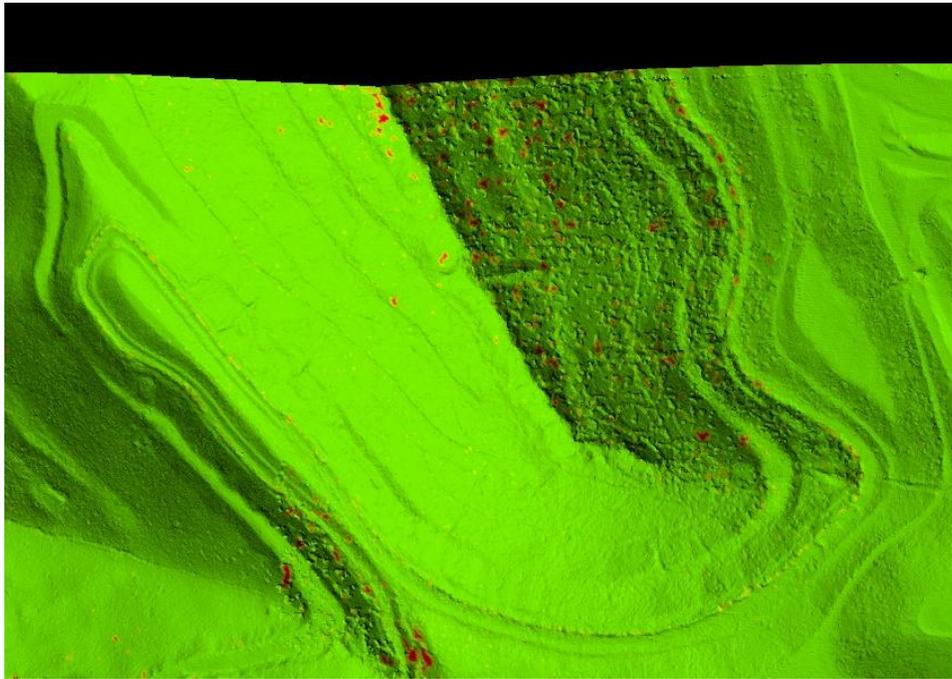
Several tiles contained noise over 20 cm. Often one side of a slope appears noisy while the other side does not. Figure 20 shows an example of this. Some noise corresponds with flight line ridges and is a result of classifying points to ground from flight lines that are offset.

Figure 20 – Noise is present on the left side of both hills. Tile C22432.

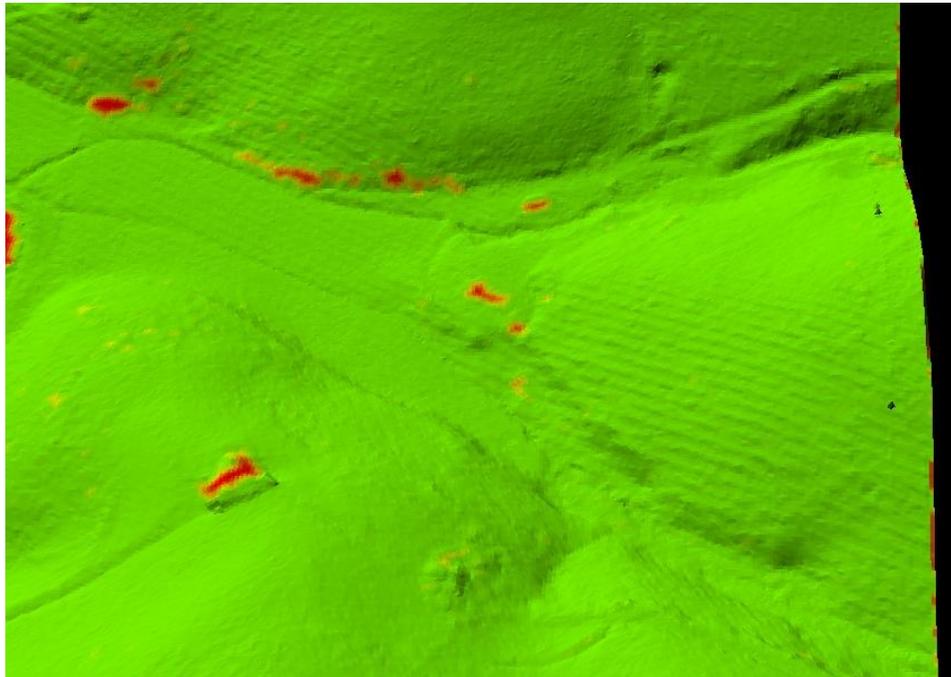
The West Virginia project specifications require a vertical error of 30 cm or less at the 95% confidence level. Based on this specification, corn rows exceeding 15 cm are considered errors which require reprocessing. No cornrows which could be reliably measured as exceeding the 15 cm tolerance were found in the data. Some instances of cornrows which average between 10 and 14 cm were observed. These were noted in LiDAR QA assessment and, while they do not strictly require adjustments, it is recommended that these corn rows be corrected both to improve the quality of the ground model and to identify possible flight line offsets. Figure 18 shows corn rows averaging 10 cm.

Figure 21 – Negligible corn rows in tile C25077 averaging 10 cm. Correcting these corn rows is recommended but not required.

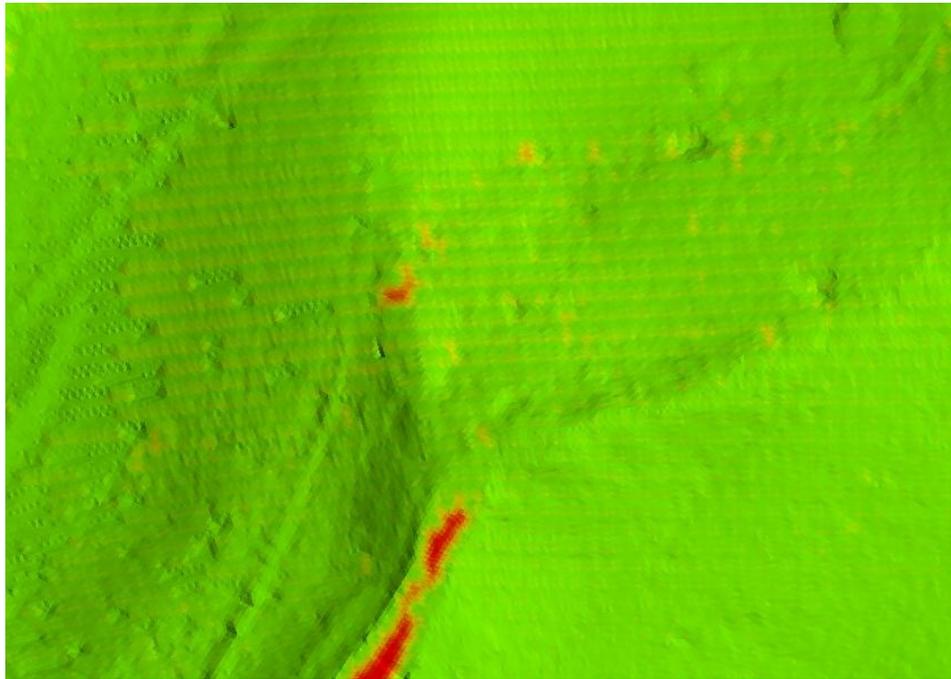
One additional inconsistency was noted. For a small number of cases, often bordering an area of cornrows, point density was low enough that the scanner pattern was clear in the ground density model. This cannot be easily fixed, however it does not greatly impact the ground model. Figure shows the linear pattern present in the ground density model for tile C27958. The yellow lines represent a scarcity of LiDAR points.

Figure 19 – Points are sparse enough that the scanner pattern becomes visible. This is noted for QA assessment, but is not expected to be resolved.
